AFRL-VA-WP-TR-2001-3004

**DC-9 AFT PRESSURE BULKHEAD
RESIDUAL STRENGTH TEST**

**AIR VEHICLES DIRECTORATE
AFRL/VASV
2790 D. STREET, ROOM 301E
WPAFB, OH 45433-7542**

FINAL REPORT FOR PERIOD OF 01 JUNE 1999 – 01 APRIL 2000

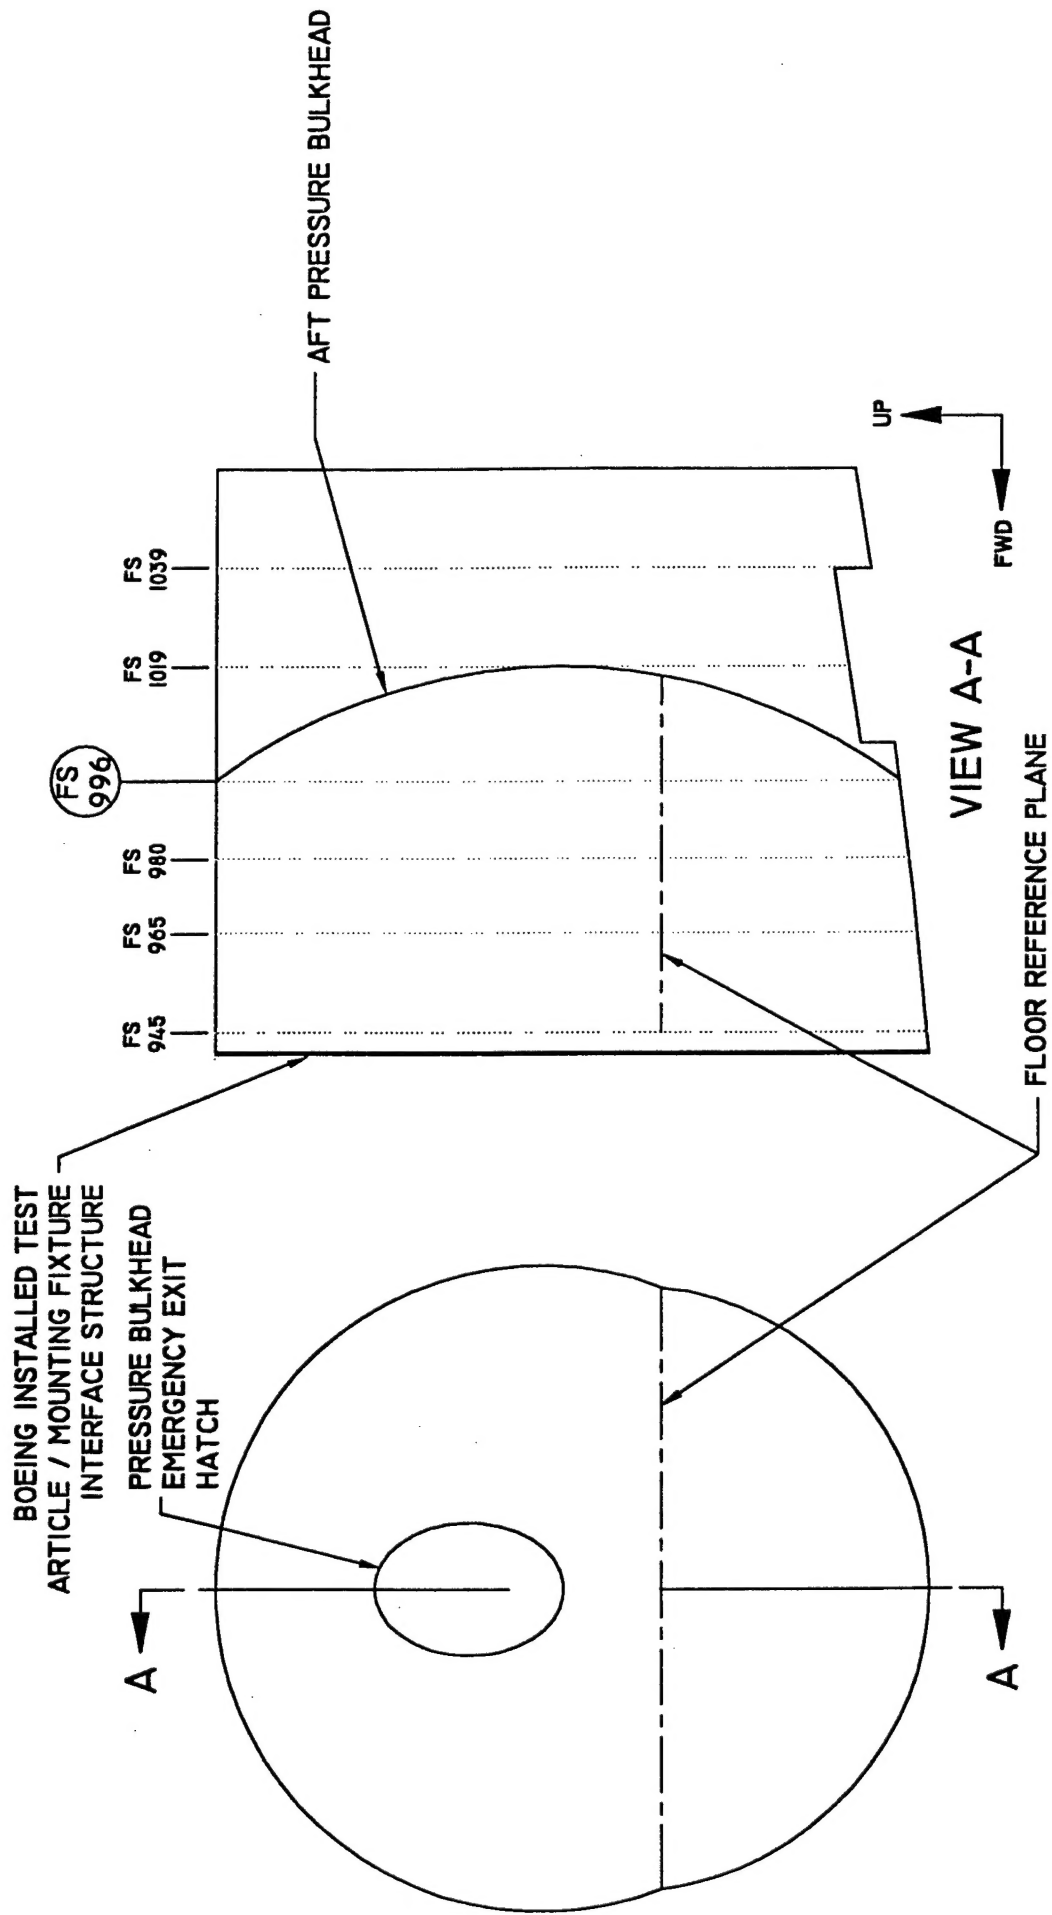
Figure 1. Aft Pressure Bulkhead Test Specimen

The test article was approximately the aft 10 feet of a DC-9 fuselage incorporating the aft pressure bulkhead (Figure 1). This particular aircraft had 57,757 landings and 60,583 flight hours. When mounted on a fixture plate, the enclosed volume was approximately 700 ft³. The test article preparation by Boeing included a) cutting the fuselage section to a manageable size, b) installing a structure forward of the bulkhead to facilitate mounting the test article and c) creating the MSD and lead crack in the pressure web (Figures 2 and 3). The AFRL/VASV at Building 65, WPAFB received the prepared test article and mounted it to a fixture plate fabricated locally. Government technicians installed all instrumentation and completed the mechanical, electrical and pneumatic systems installations as required (Figures 4 and 5).

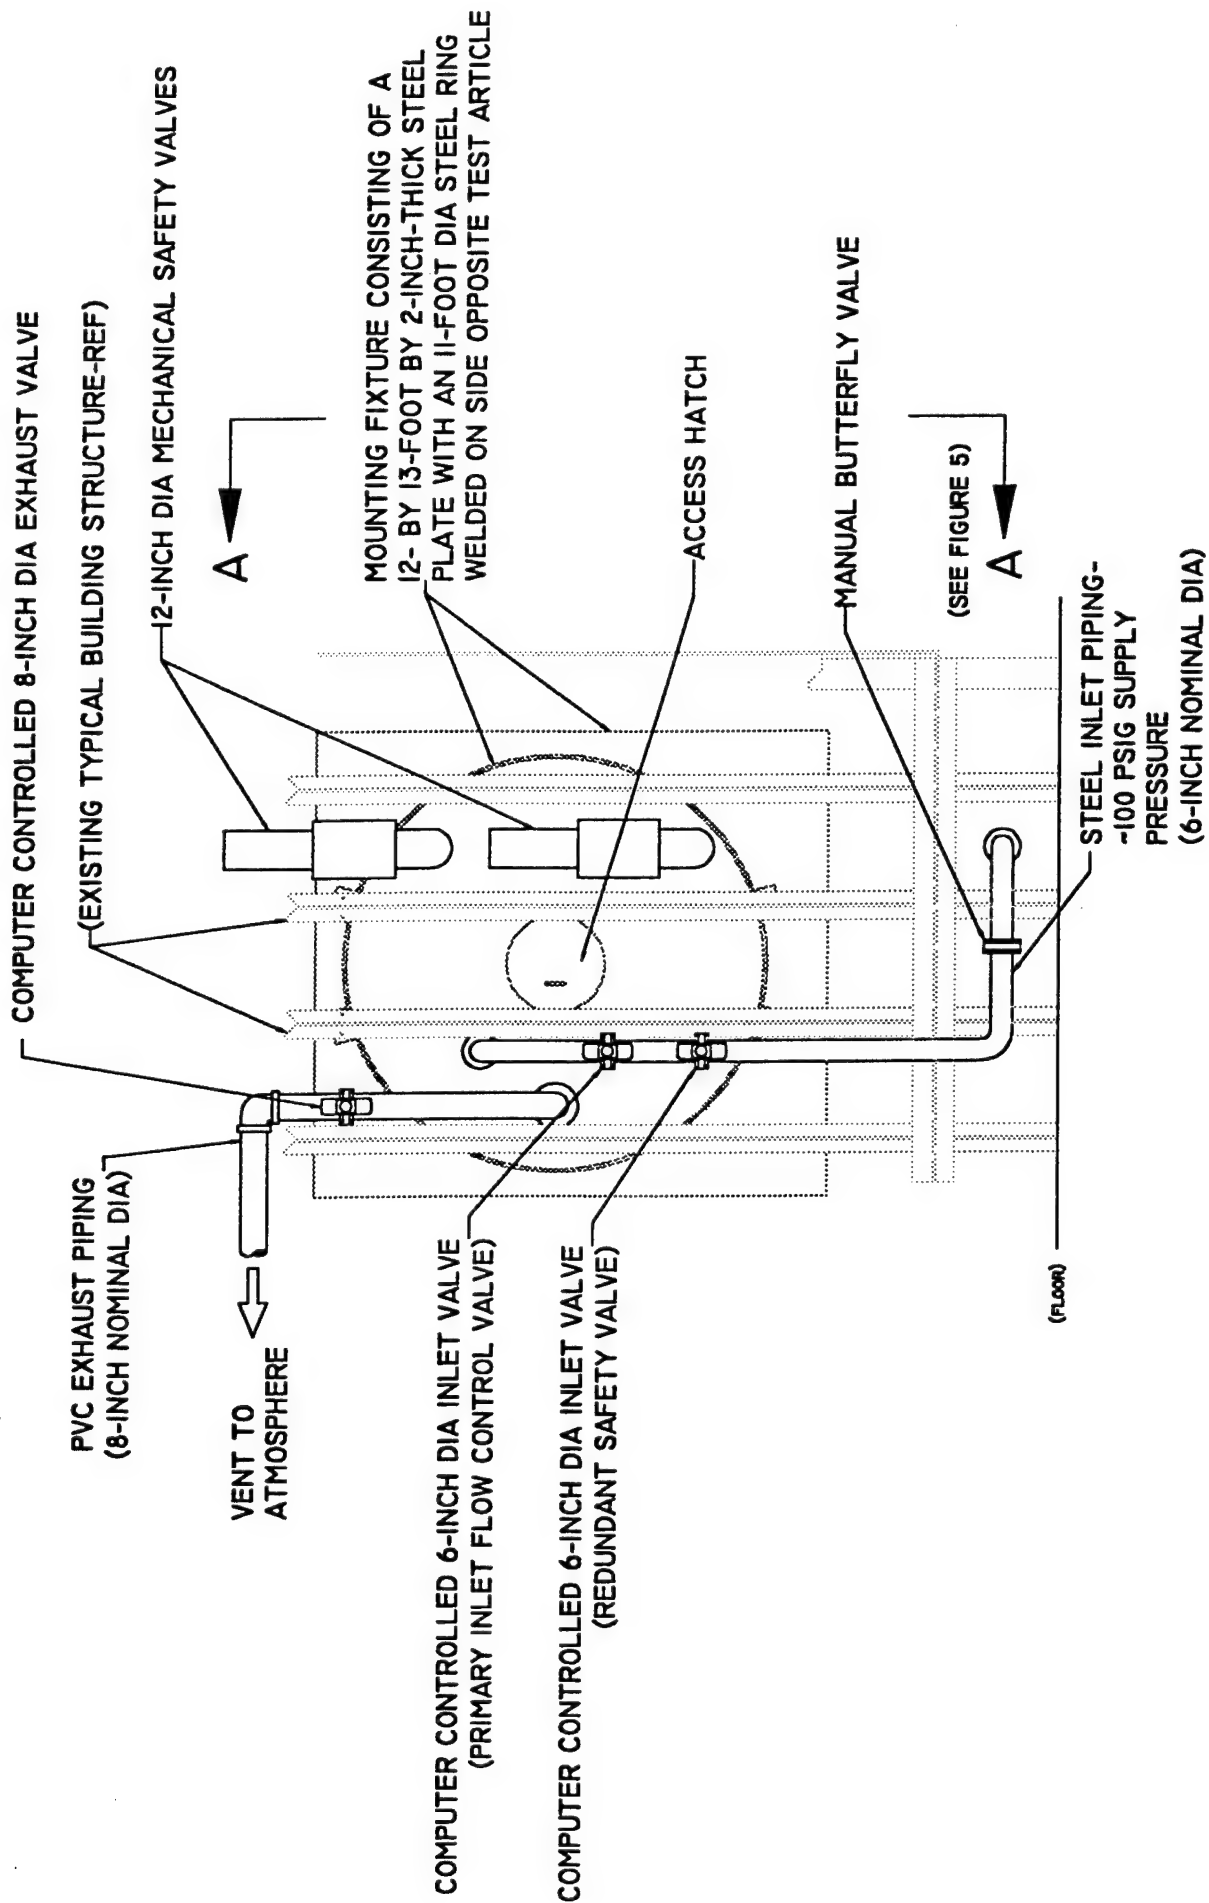
Figure 4. Test Setup, Front View

In this program, the aforementioned DC-9 fuselage section was fastened to the mounting fixture. This fixture consisted of a 2-inch by 12- by 13-foot American Society for Testing and Materials (ASTM) A-36 steel plate with a 1-inch thick by 11-foot-diameter ASTM A-36 steel ring welded to the side opposite the test article. This ring had four brackets welded onto its periphery to mount the entire assembly to Building 65's existing test support structure using eight 3/4-inch-diameter bolts (AN12-27). Two 12-inch diameter mechanical safety valves, the 6-inch-diameter inlet port, the 8-inch-diameter outlet port, various data and power feed-throughs, and a hinged access hatch were also incorporated into the plate. The test article was mounted via 360 3/8-inch diameter Society of Automotive Engineers (SAE) grade 5 bolts. These fasteners clamped the fuselage transition structure installed by Boeing to the 2-inch-thick steel mounting plate. To minimize air pressure loss, the fasteners passing through to the inside of the test article were installed wet with Dow Corning 733 RTV Sealant. The pilot holes for these fasteners were drilled in the test article transition structure by Boeing-Long Beach. These hole locations were then transferred to the mounting plate and drilled and tapped as necessary.

An epoxy liquid shim (Magnolia Plastics Compound 1039 with 323-C Curing Compound) was used between the test article and the 2-inch-thick plate to ensure that no undesirable loads were introduced into the test article when bolted together. This was necessary because significant warping occurred in the 2-inch-thick plate when the ring was welded to the side opposite the test article. A silicone-based release agent (Mann Formulated Products Ease Release 200) was applied to the fuselage mounting flange to facilitate removal. Prior to final assembly of the steel plate and the test article, Dow Corning 733 RTV sealant was applied to the mating surfaces to ensure an airtight joint. For personnel protection from flying debris when the test article failed, the three open sides around the test article were enclosed with 3/4-inch-thick plywood mounted to steel supports. The area above the test article was left open to allow for pressure relief when test article failure occurred.

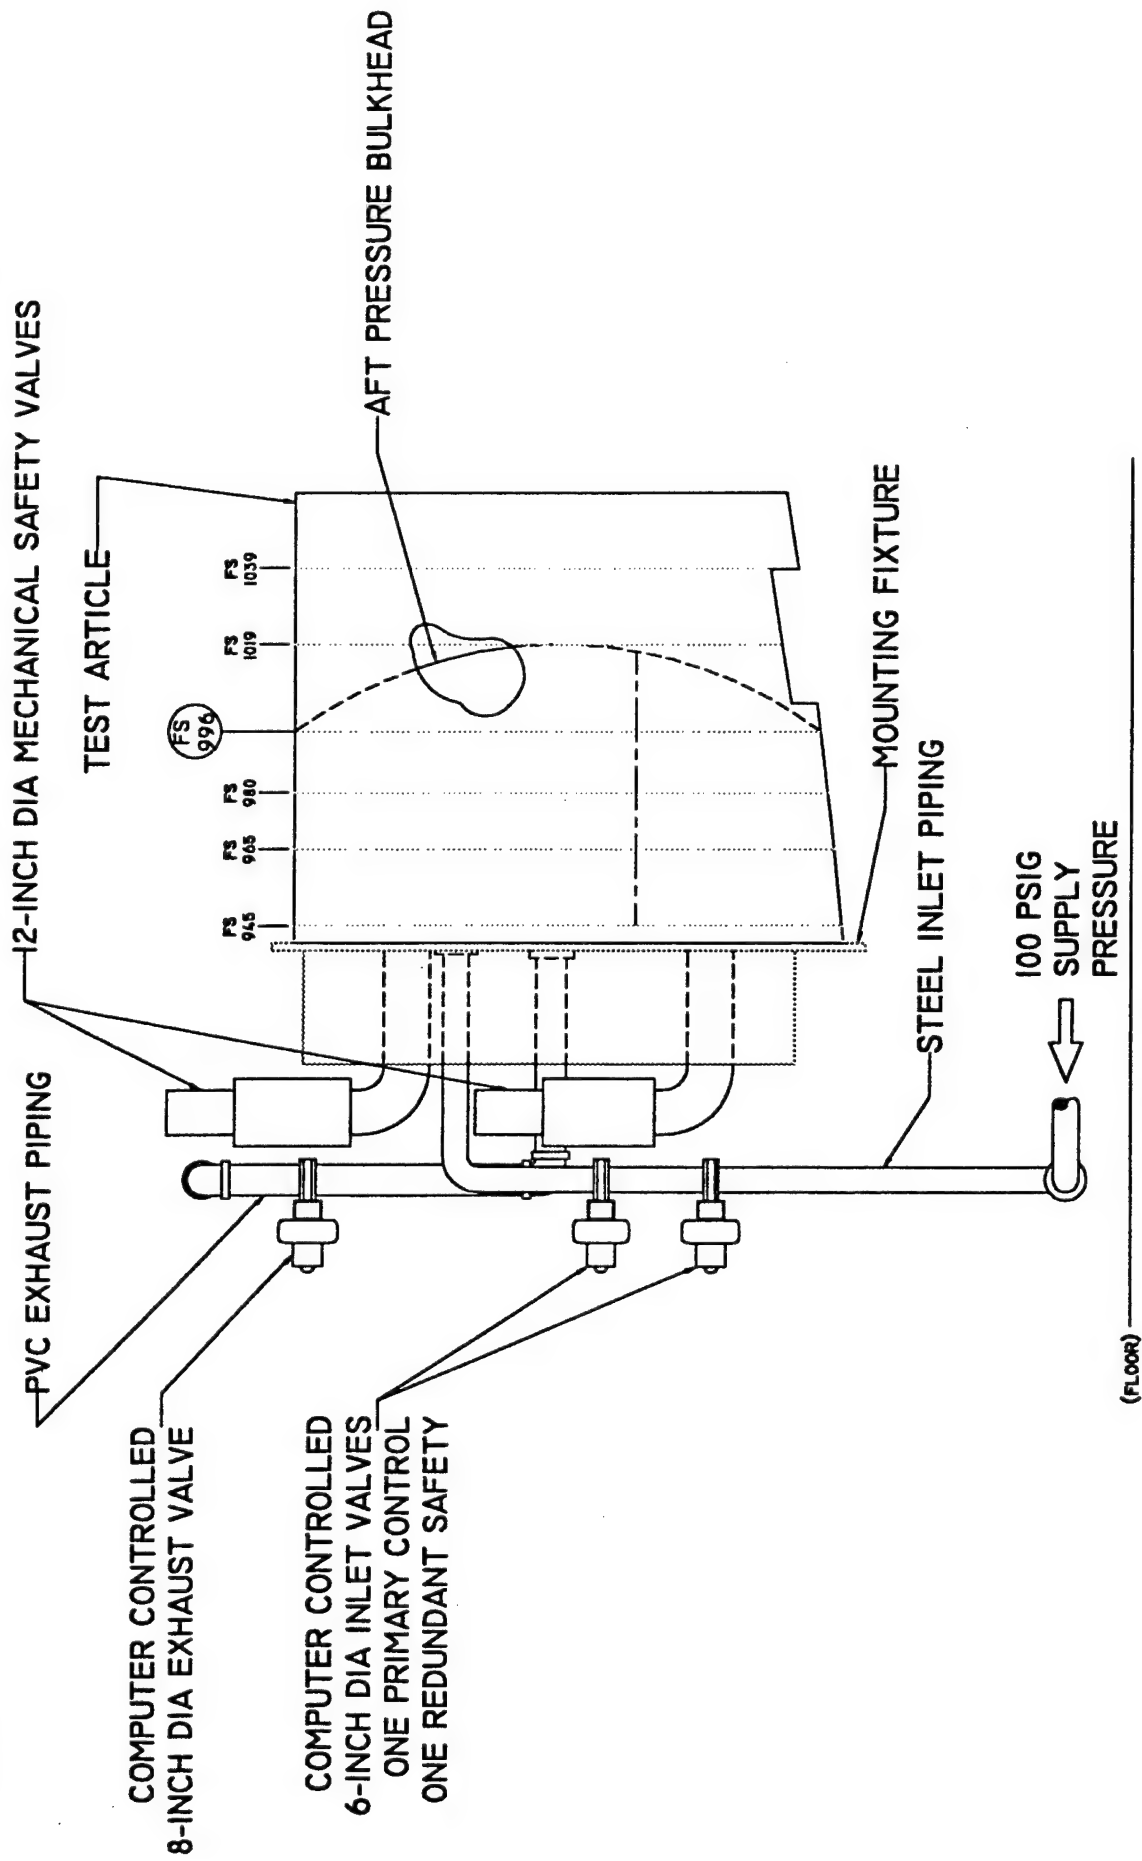
Figure 5. Test Setup, Side View

VIEW A-A (SEE FIGURE 4)
 (NOTE: EXISTING BUILDING STRUCTURE NOT SHOWN FOR CLARITY)

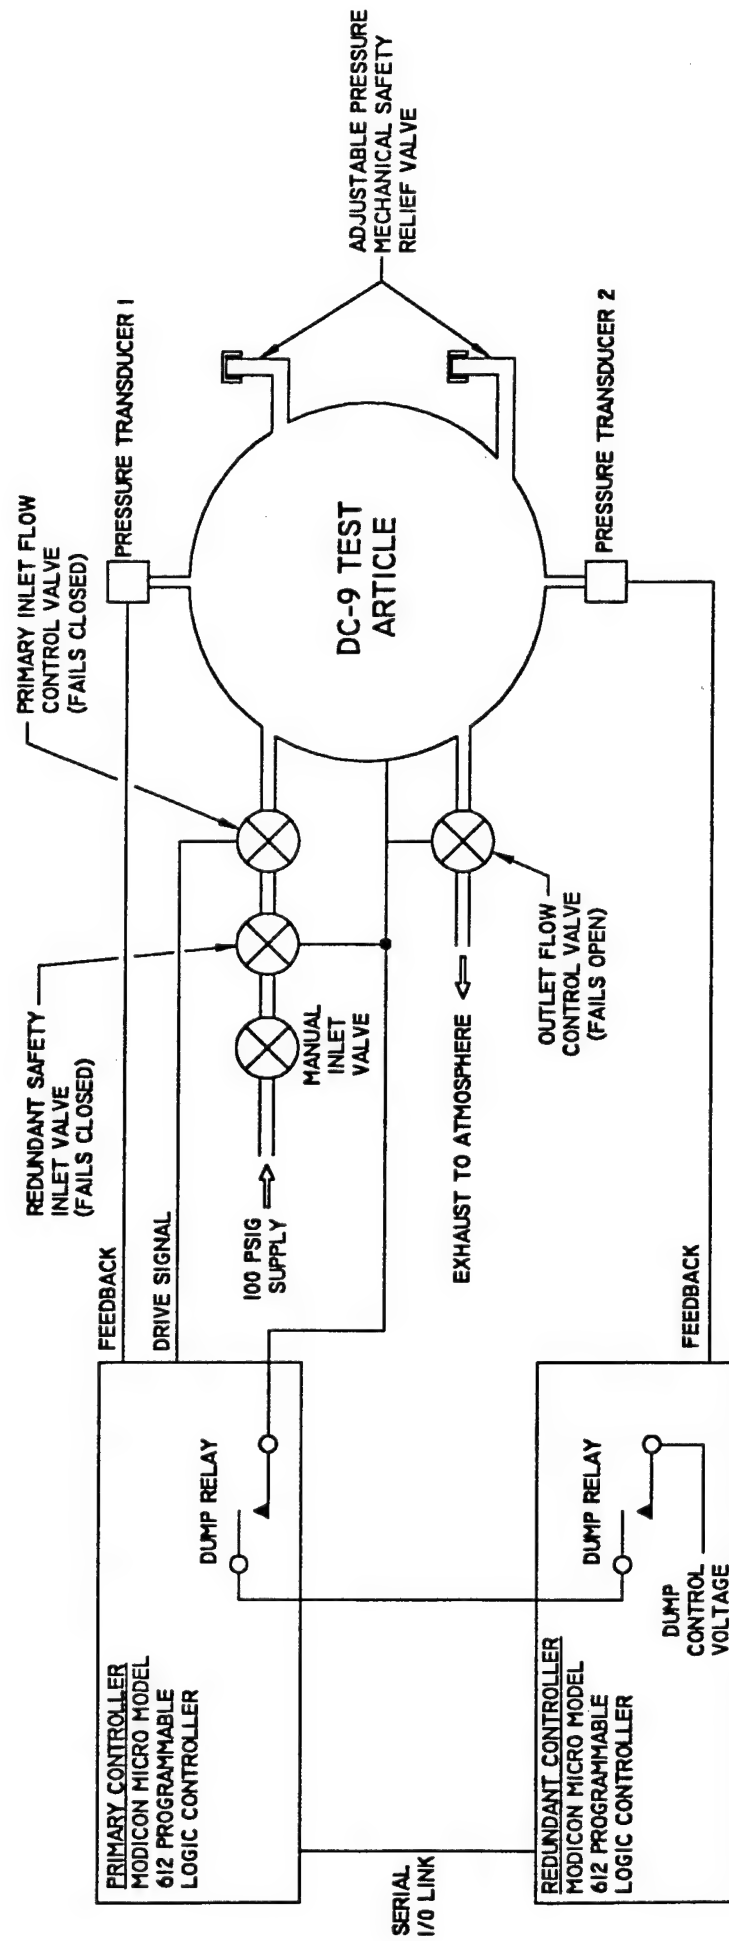
Figure 6. Test Control System Schematic

Refer to figure 6. Two Modicon Micro Model 612 programmable logic controllers (one primary, one redundant) were utilized for this test. The primary controller used the feedback from one of the pressure transducers in generating the drive signal to the 6-inch-diameter primary inlet valve. During normal operation, this controller would close the 8-inch-diameter exhaust valve, fully open the redundant 6-inch-diameter inlet valve, and modulate the primary inlet valve to achieve a haversine pressure versus time profile within the test article. Once the specified upper pressure limit was attained, the controller would close both primary and redundant inlet valves and open the exhaust valve until the lower pressure limit was achieved. The cycle would then repeat as necessary.

The second redundant controller was linked in series to the primary controller and sampled the feedback from a different pressure transducer. The primary program signal and step number were sent to the redundant controller over the serial I/O link. The redundant controller used the step number to calculate the expected program signal. The expected and primary program signals were compared (program signal verification). If the two did not match, the test was dumped by the redundant. Bits were toggled between the primary and redundant over the serial I/O link. If the bits stopped toggling for 50 ms, the test would be dumped by either controller.

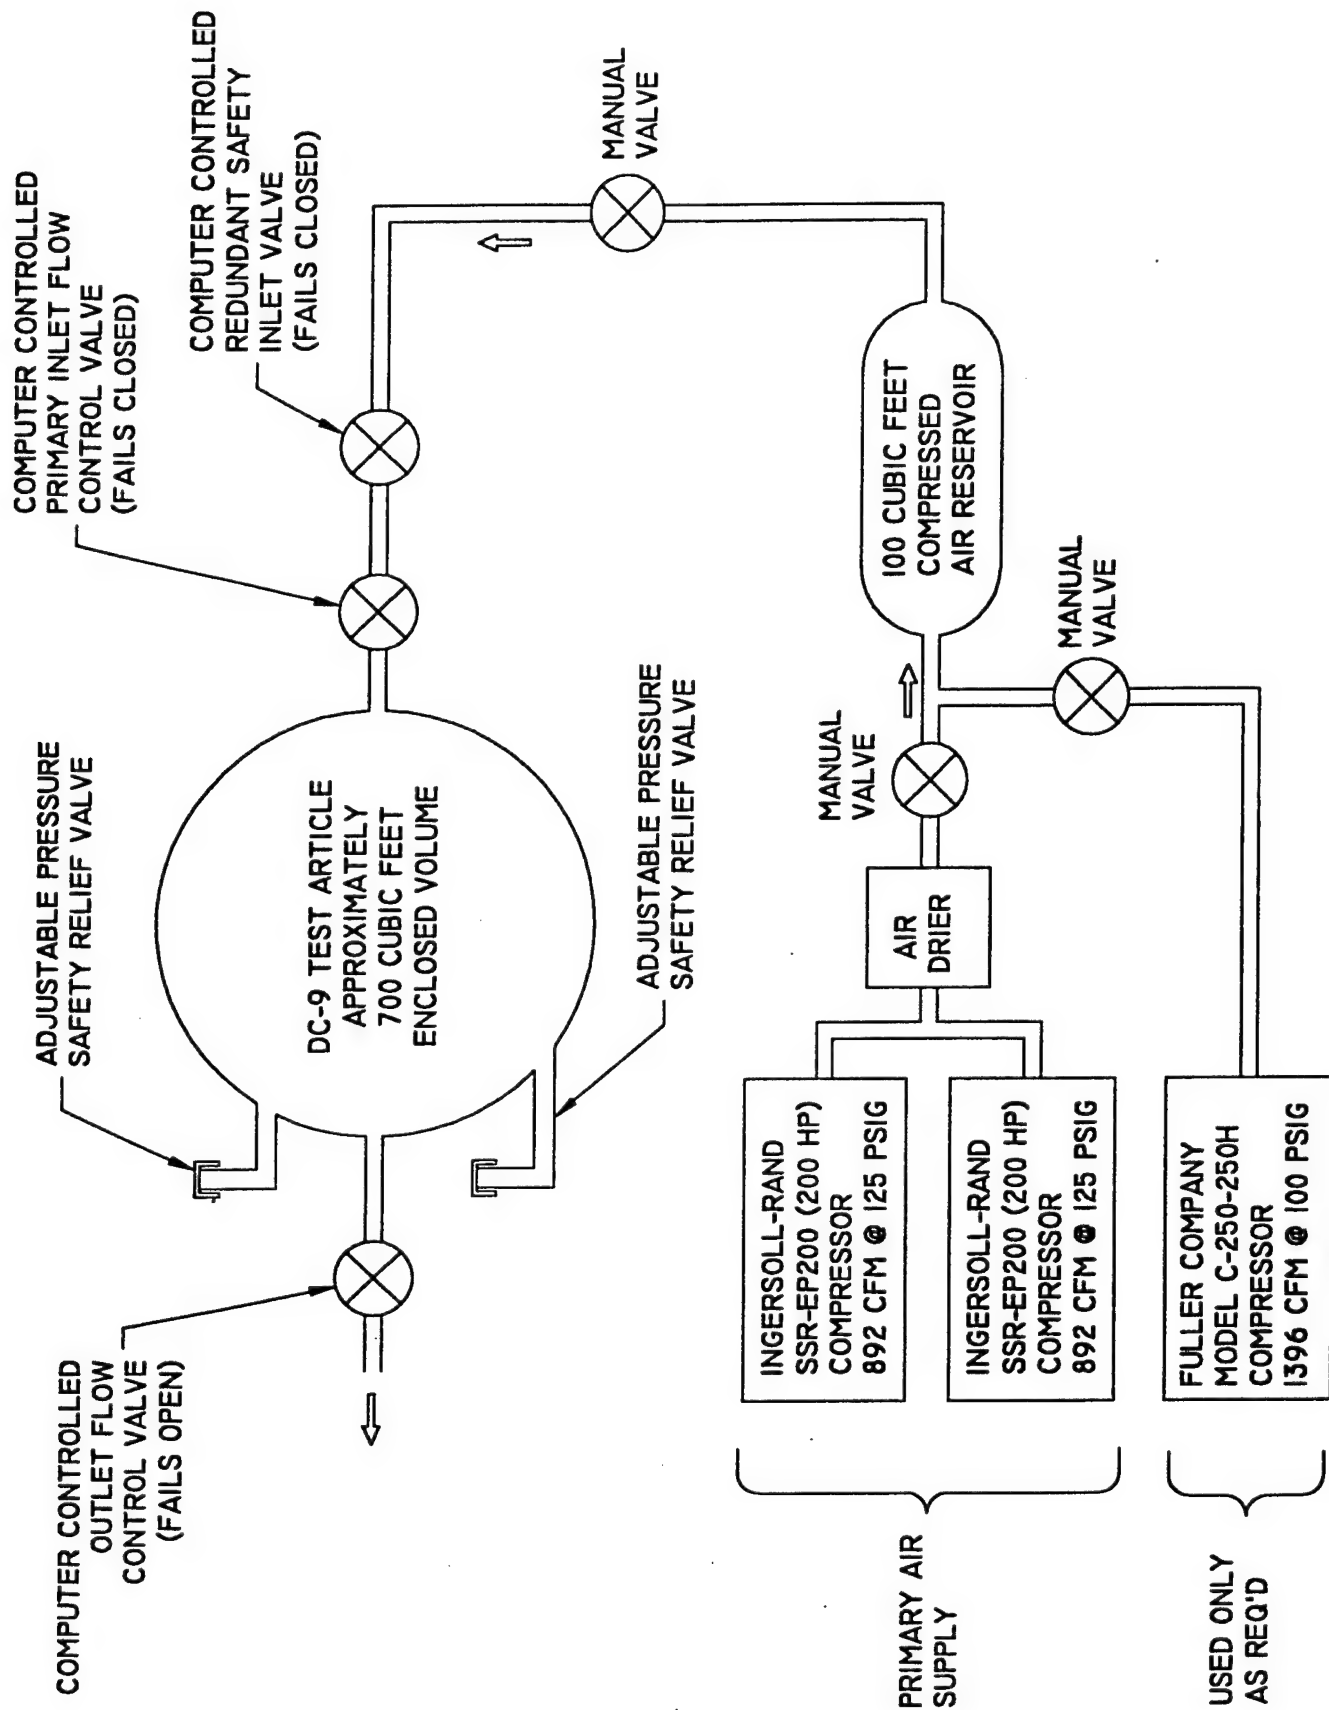
Figure 7. Test Pneumatic System Schematic

Refer to figure 7. The shop air system at Building 65 consisted of two Ingersoll-Rand SSR-EP200 (200 HP) air compressors with a nominal output of 892 cubic feet per minute (CFM) @ 125 psi each. These fed a 100 ft^3 accumulator via a filter/drier unit. Air inlet to the test article was accomplished by a 6-inch-diameter, schedule 40 steel airline from the accumulator to the 2-inch-thick mounting plate. In this airline, two electronically controlled, pneumatically operated, 6-inch-diameter butterfly valves were placed in series. One of these was the primary inlet flow control valve while the second one was used as a redundant safety valve. These inlet valves were sized based on the preliminary understanding that the test article would have an enclosed volume of approximately 2000 ft^3 . They were ordered and received prior to the delivery of the test article, which actually had a volume nearer to 700 ft^3 .

These Flowserve Corp. Automax valves are normally closed. In the event of an electrical power loss or pneumatic control failure, these valves would automatically return to a closed position, thus shutting off the inlet air supply. The electronically controlled, pneumatically operated, 8-inch-diameter butterfly outlet valve was plumbed to exhaust the test article air up and away from the test control center. This Flowserve Corp. Automax valve is normally open. In the event of an electrical power loss or pneumatic control failure, this valve would automatically return to an open position, thus releasing all pressure from the test article. Eight-inch-diameter, schedule 40 polyvinyl chloride (PVC) pipe was used for the exhaust line. Two short, 12-inch-diameter steel lines were used with calibrated weights as mechanical safety valves. These weights were adjustable to permit variable pressures within the test article.

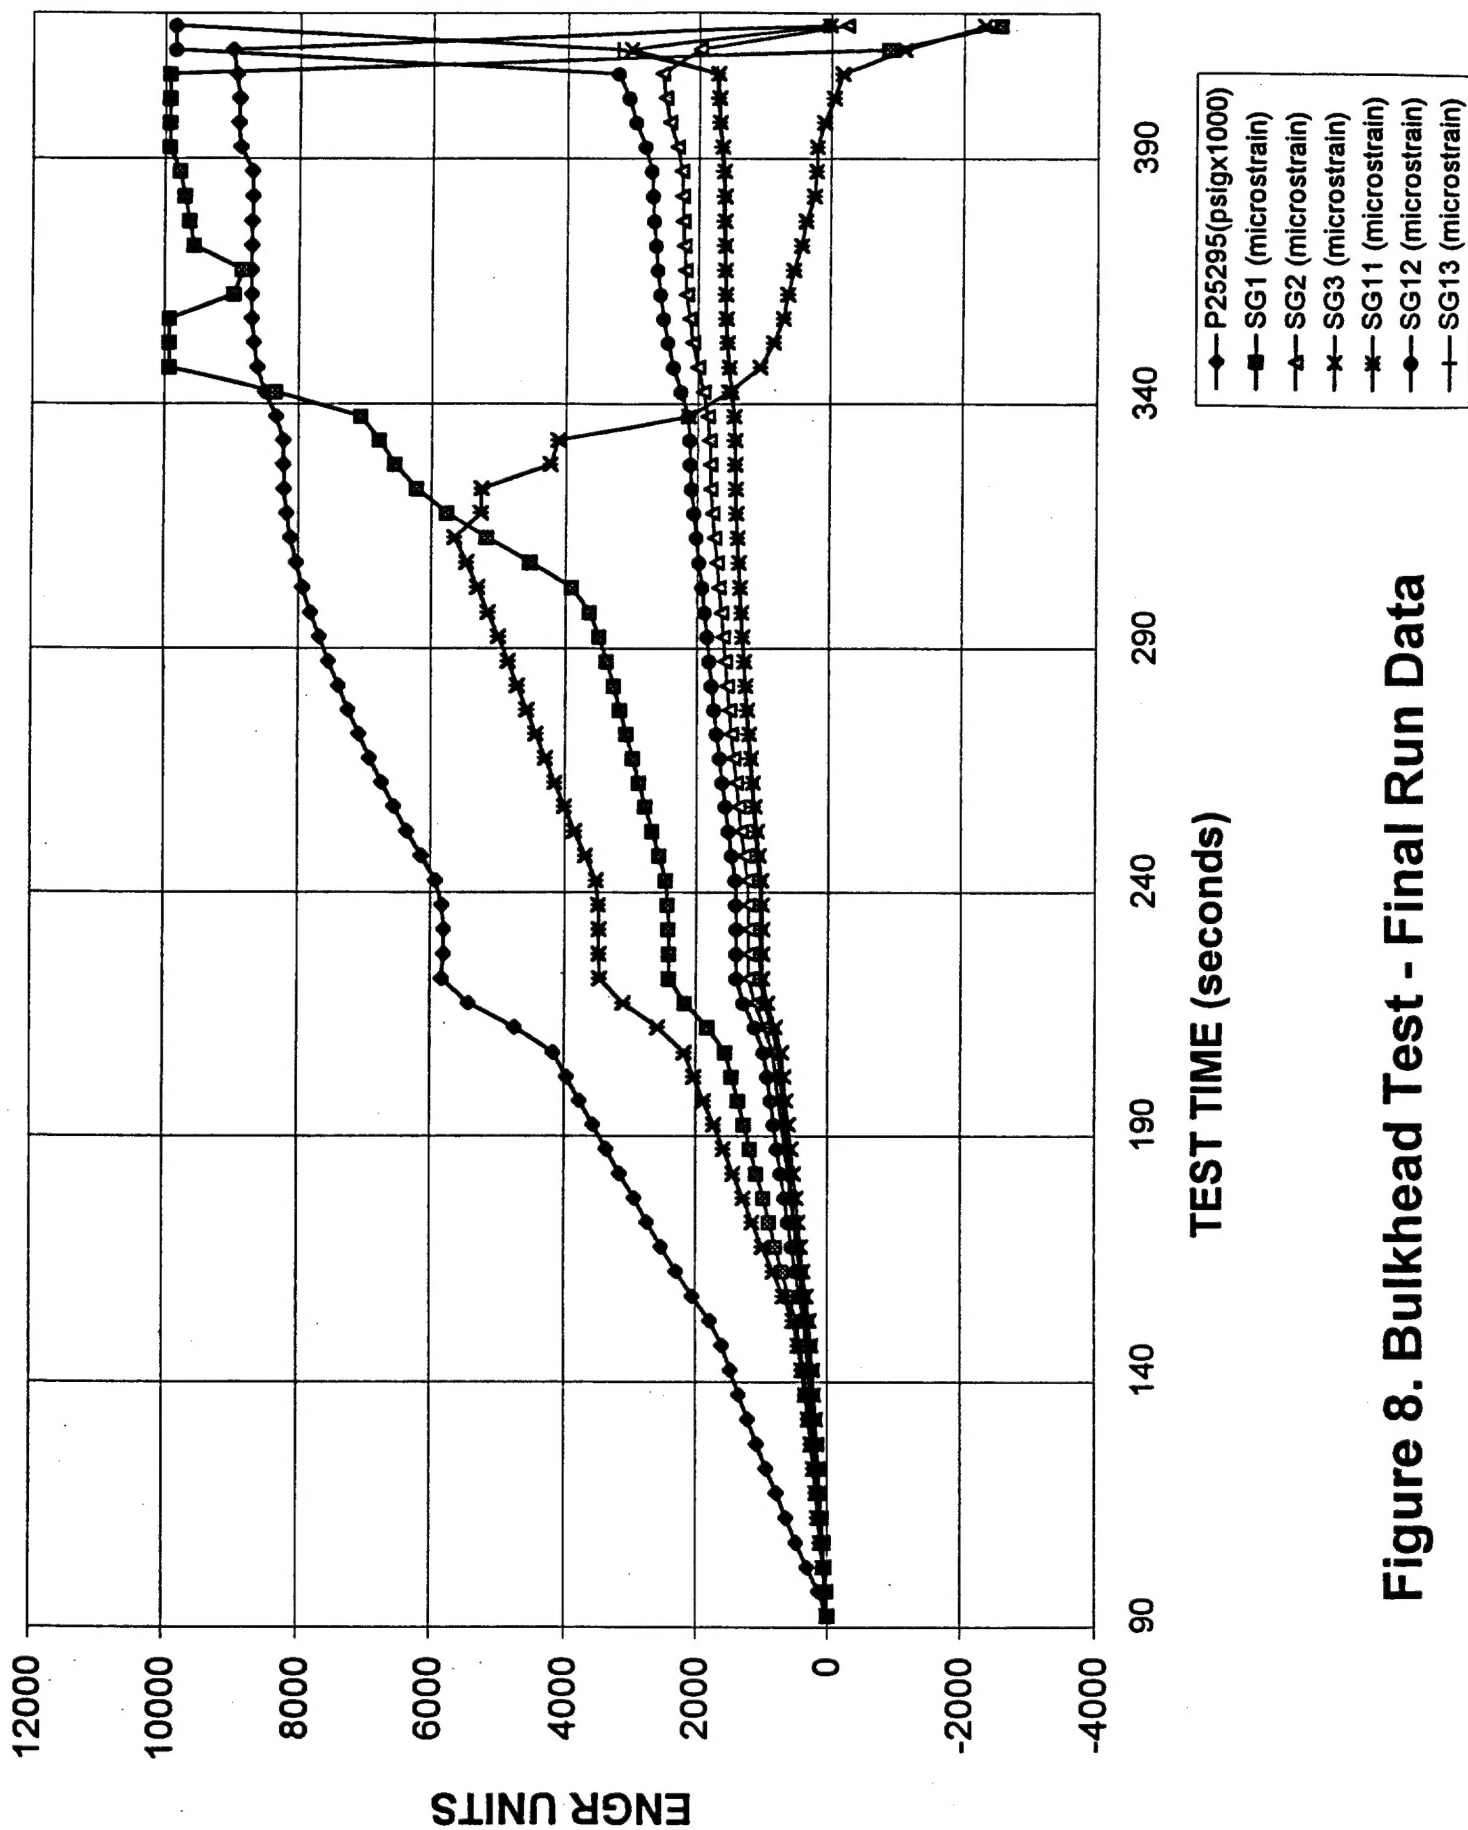
Figure 8. Bulkhead Test - Final Run Data

As evident from Table 1 and by the graphs in Figures 8 and 9, up to a test time of approximately 300 seconds at a pressure of 7.94 psig, strain gages SG1, SG2, SG3,

SG11, SG12, and SG13 recorded a strain level mirroring test article pressure. These strain gages are of particular interest since SG1 through SG3 were in sequential order from the top end of the lead crack tip and SG11 through SG13 were in sequential order from the bottom end of the lead crack tip. At a test time of approximately 300 seconds, the output of SG1 indicated a strain level rising much quicker than the test article pressure. Approximately 10 seconds later at a pressure of 8.11 psig, SG11 reached its maximum value and failed. Gage SG1 failed at 407.45. The final bulkhead failure sequence began at time 408.80 at a pressure of 8.99 psig when SG12 began a rapid rise, followed by SG2 at time 408.90. At test time 409.95, SG2 failed and the upper lead crack tip extended to the next rivet hole, followed rapidly by SG3 and SG13 at 410.10. At test time 410.15, the test article pressure began to fall as the crack extended and vented the compressed air faster than the control system could accommodate the loss. Finally, at test time 410.20, the pressure dropped rapidly, indicating total failure of the bulkhead structure.

The test setup was then modified for what was anticipated to be the final phase of testing. The control system and mechanical safety exhaust valve were recalibrated for the required 9.50 psig test article pressure. During the run up to 9.50 psig, the data and video systems captured the final moments of the test when strain gages SG11 and SG1 failed in succession to be followed by the entire bulkhead structure. This occurred between 8.97 and 8.99 psig as recorded by pressure transducers P-25316 and P-25295, respectively.

Clearly, the early failure of the structure indicated that the initial analysis was flawed in that the lead crack was already at a critical length without the need for cycling to sharpen the crack tips. In retrospect, the manufactured initial crack length (sawcut) should have been shorter to enable cycling to sharpen the crack tips and yield a more realistic test. However, prior to the 2nd day of testing, the Boeing personnel present indicated that newer revised analyses had predicted failure at approximately 9.2 psig with a crack length of 10.5 inches. This was within three percent of the actual failure load. For this final run, the elapsed time from the initial pressurization to bulkhead failure was 5:18.60. The sequence of events is summarized in Table 1.
